Tlicho All Season Road (TASR) 2017 Geotechnical Investigation of Granular & Bedrock Prospects

PRESENTED TO

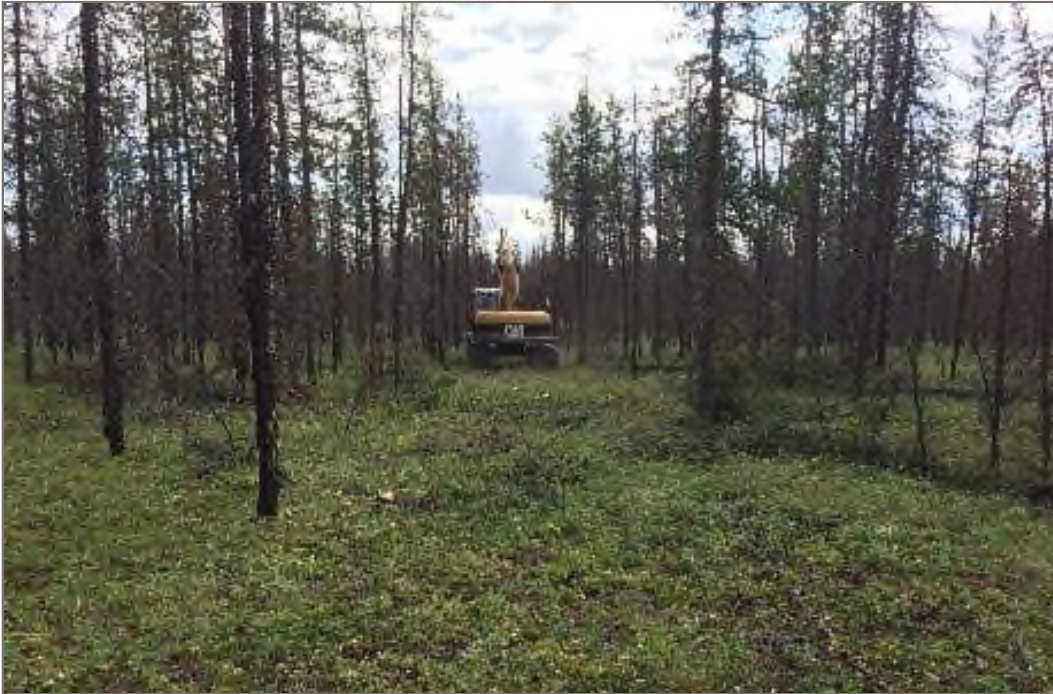
Photo 1: Prospect 1 Cutline. Partial forest fire region.
Photo taken July 13, 2017

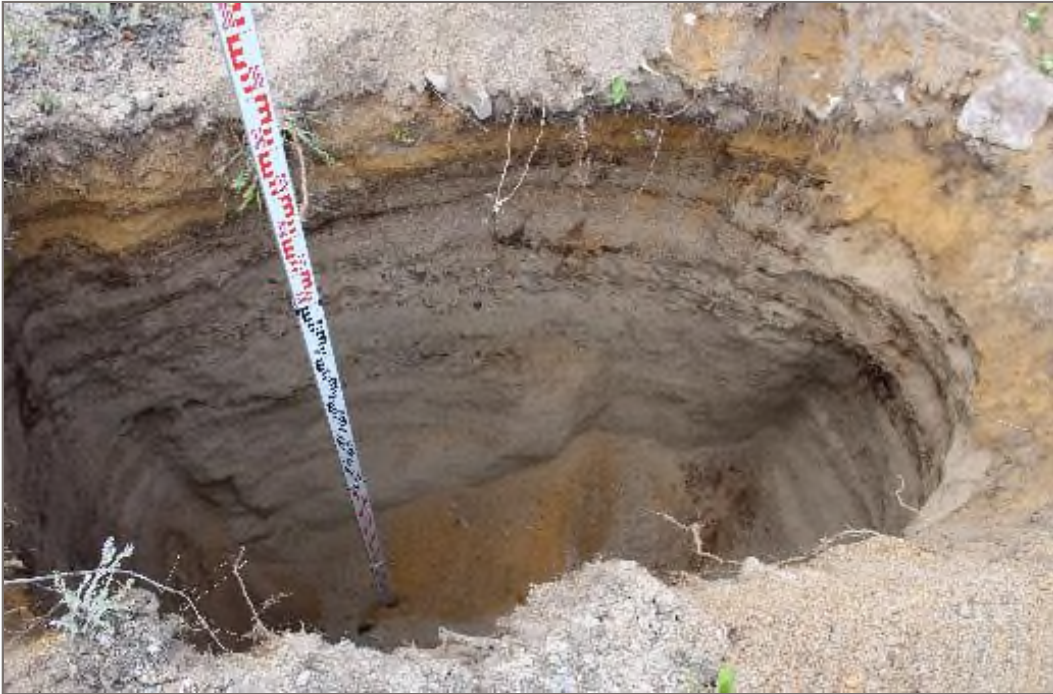
Photo 5: Prospect 1-23. Dry to damp fine grained sandy overburden encountered with gravel seams observed near the surface.
Photo taken July 14, 2017

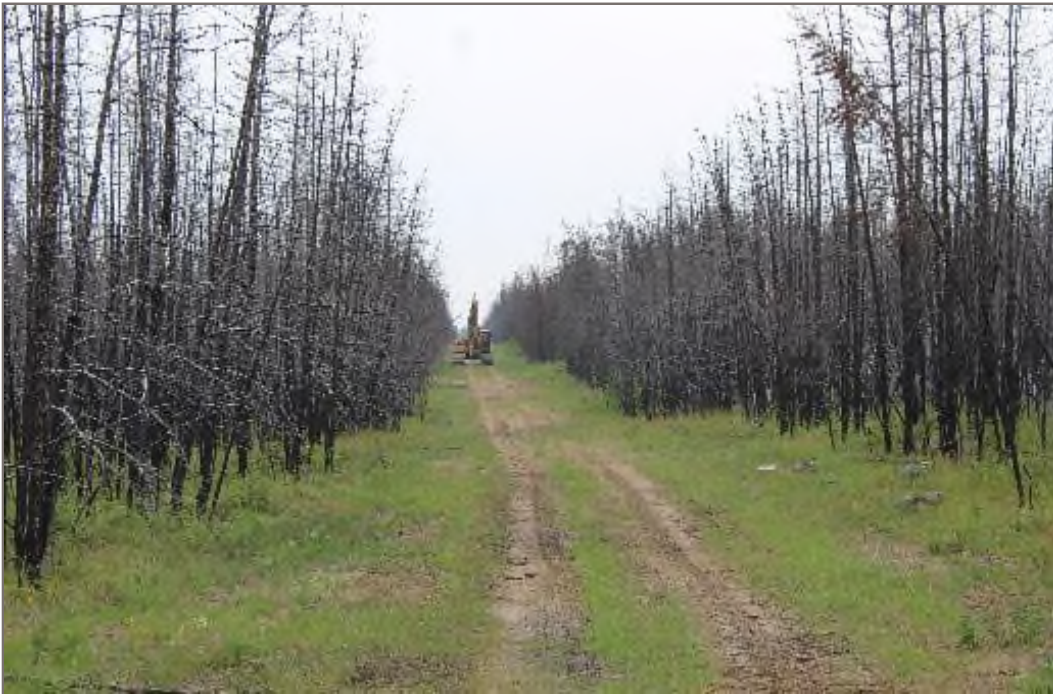
Photo 6: Prospect 13B. TASR alignment / old winter road.
Photo taken July 11, 2017

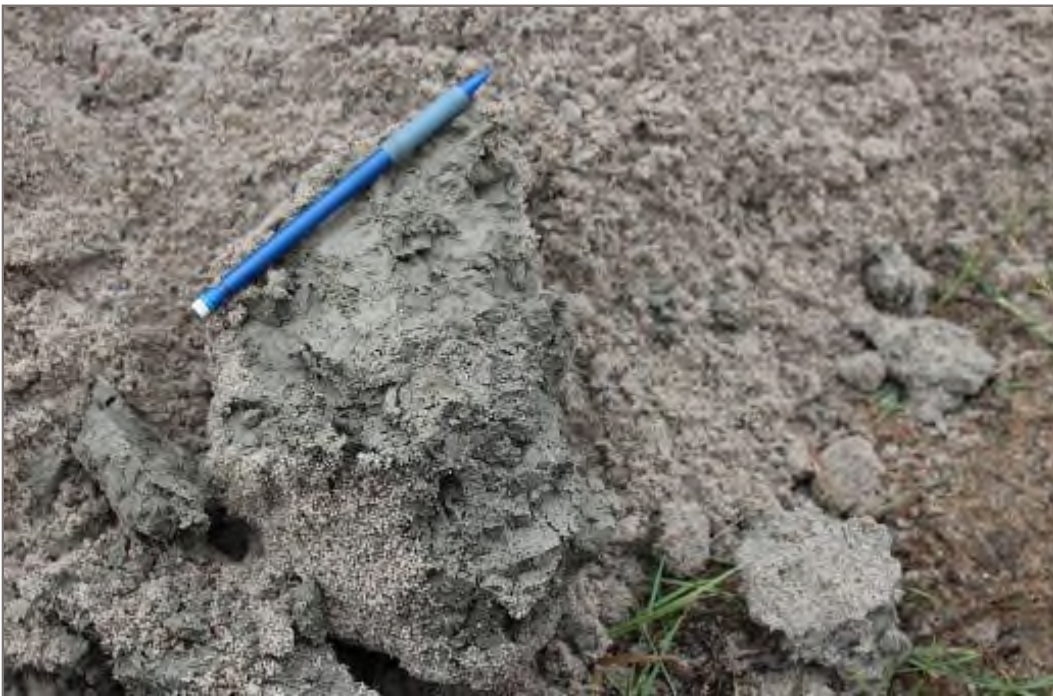
Photo 10: Prospect 13B-05. Overburden was a fine grained sand. At 3.1 m, a clay till was observed. Probably bedrock inferred at 4.0 m
Photo taken July 11, 2017

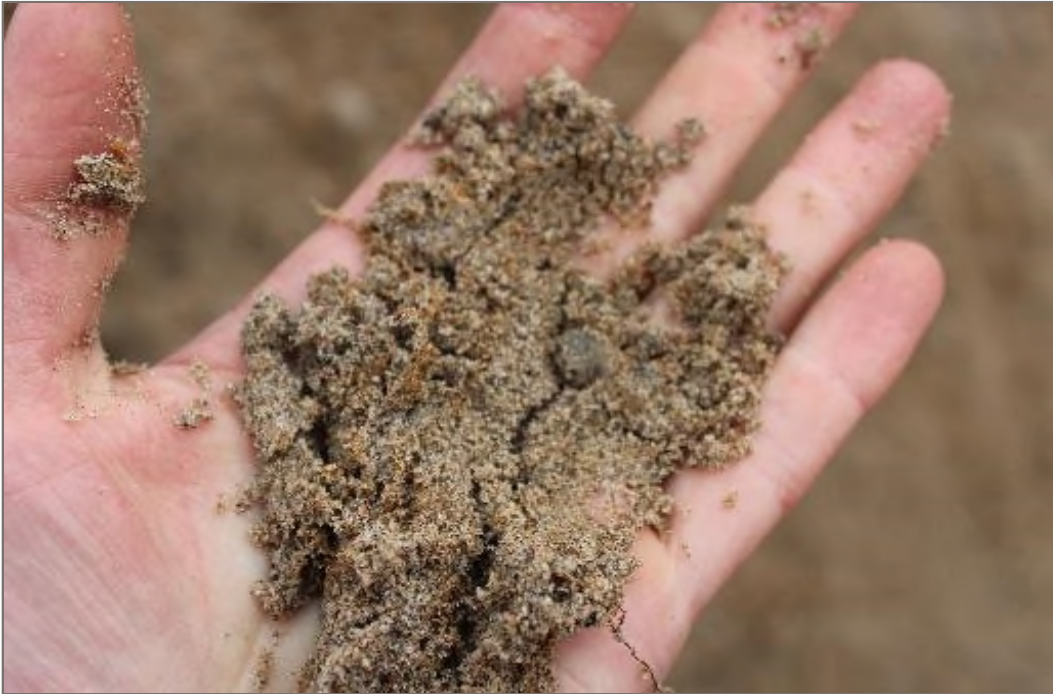
Photo 11: Prospect 13B-07. Close up of the near surface red brown well graded sandy soil. Below a metre, the sand was typically fine and grey in colour.
Photo taken July 11, 2017

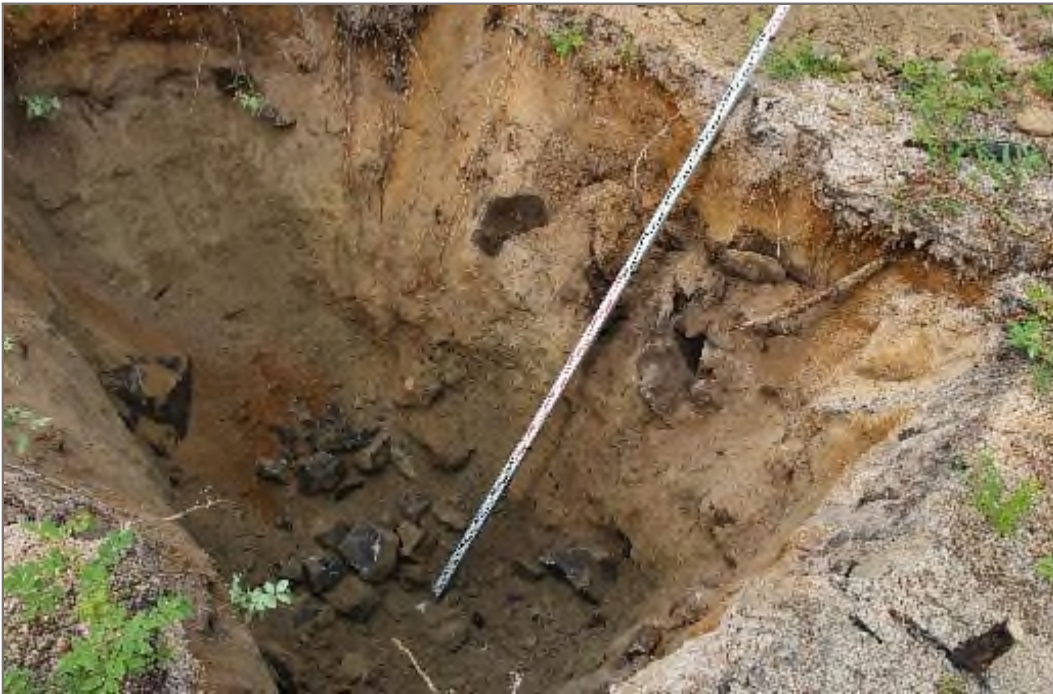
Photo 12: Prospect 13B-08. Rock fragments were observed in Testpit 08 well above the sand / bedrock interface.
Photo taken July 11, 2017

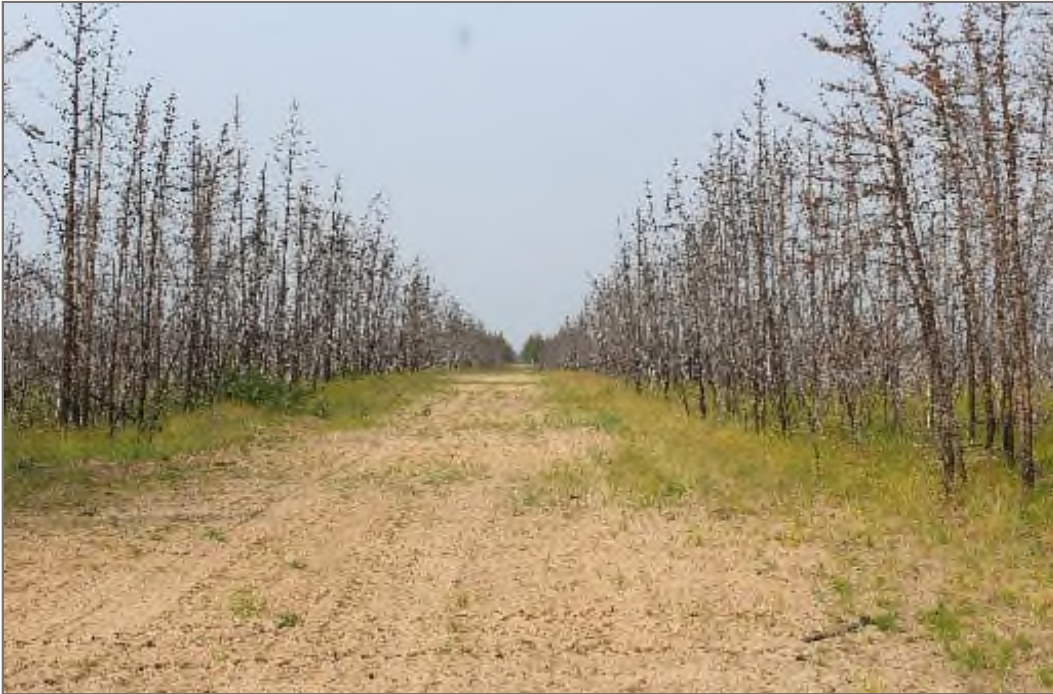
Photo 13: Prospect 13C. TASR alignment / old winter road.
Photo taken July 11, 2017

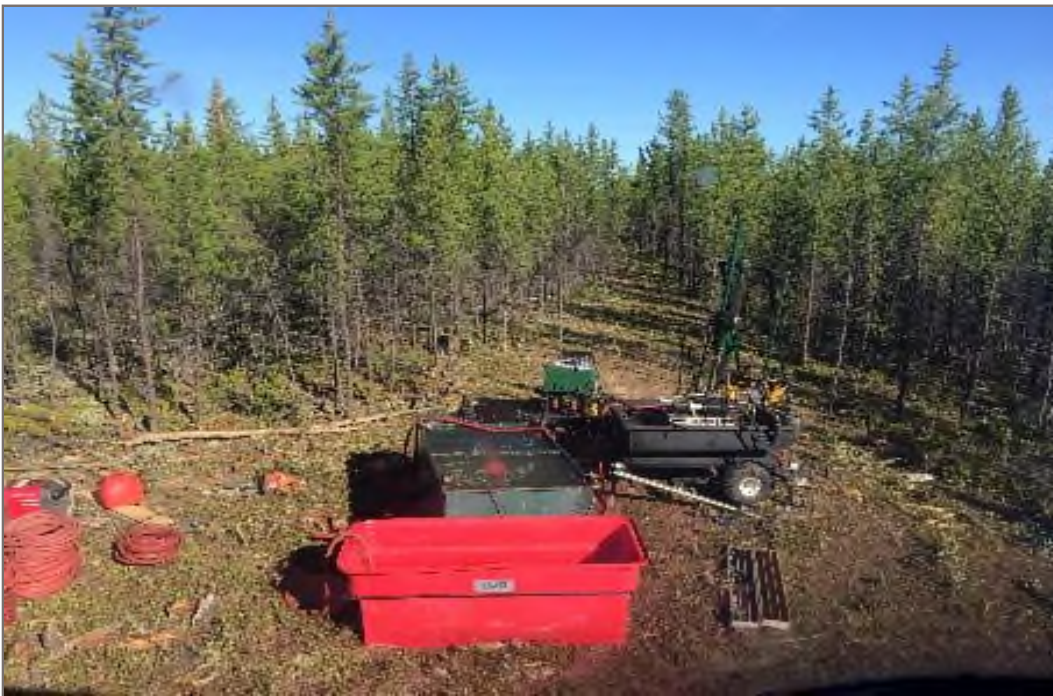
Photo 32: Prospect 69-05d. Diamond drill setup. Limestone bedrock observed at 7.2 m depth.
Overburden considered to be GRAVEL, sandy, trace to some cobbles, trace silt.
Photo taken July 23, 2017

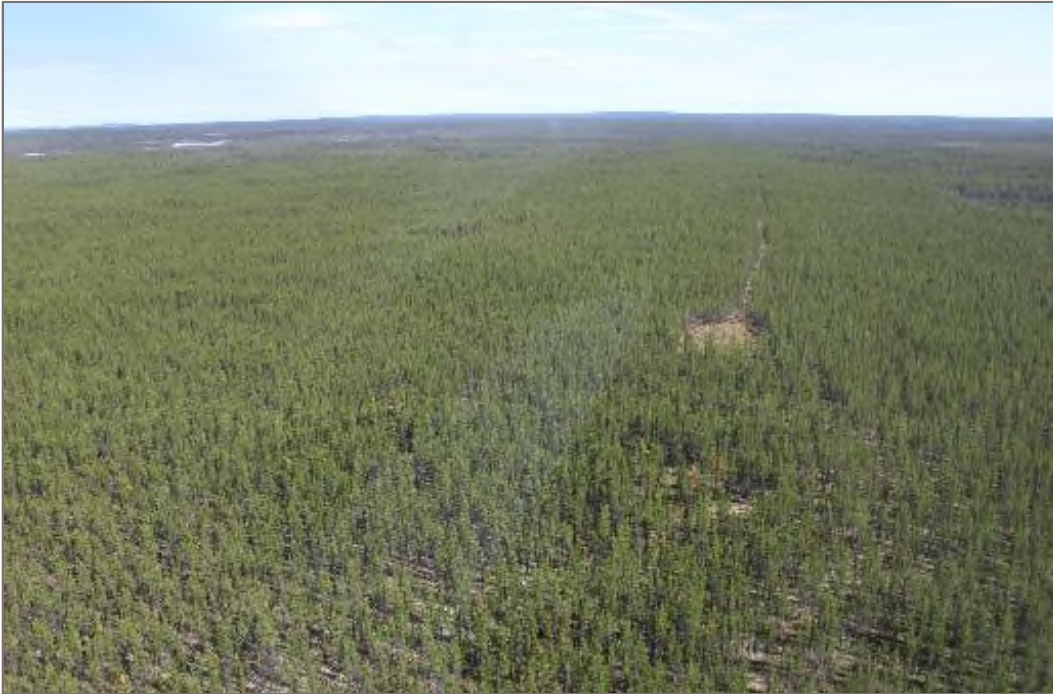
Photo 33: Prospect 69. Airborne looking east Prospect 69. View looking east towards the landing zone and cutline.
Photo taken July 23, 2017

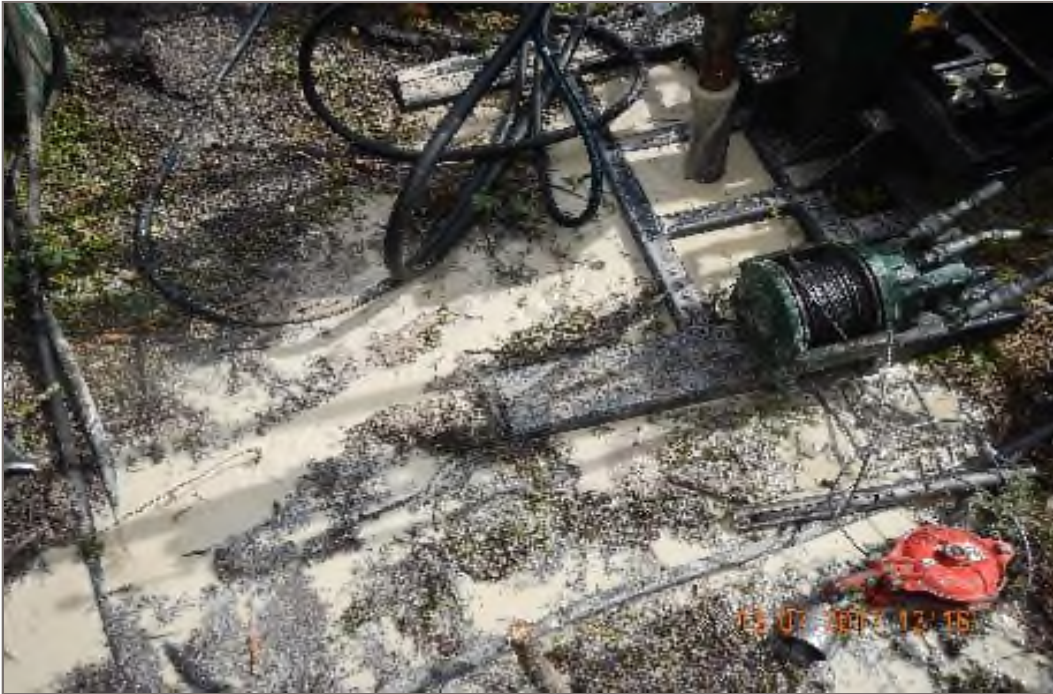
Photo 45: Prospect 86. Fine grained limestone/dolomite sands returned at drill collar annulus in water return. Sands were not recovered in drill core, but were observed in pitted vuggy dolomite core. Photo taken on July 13, 2017.

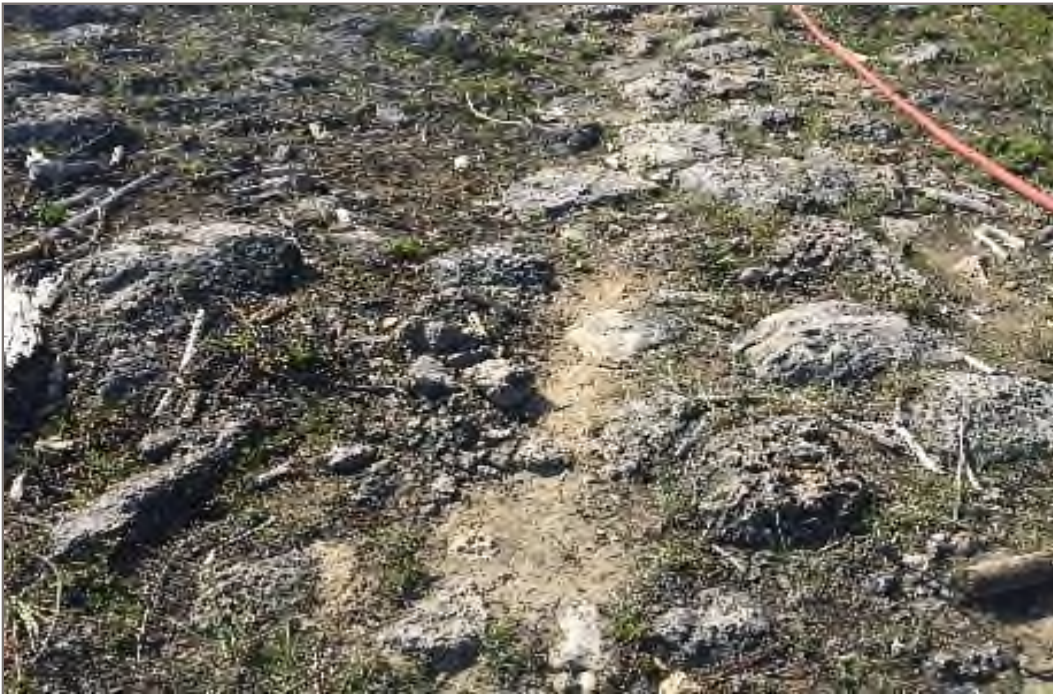
Photo 46: Prospect 86. Photo taken between P86-01 and helicopter landing zone. Weathered, vuggy calcitic dolomite boulders outcropping at surface. Photo taken on July 12, 2017.

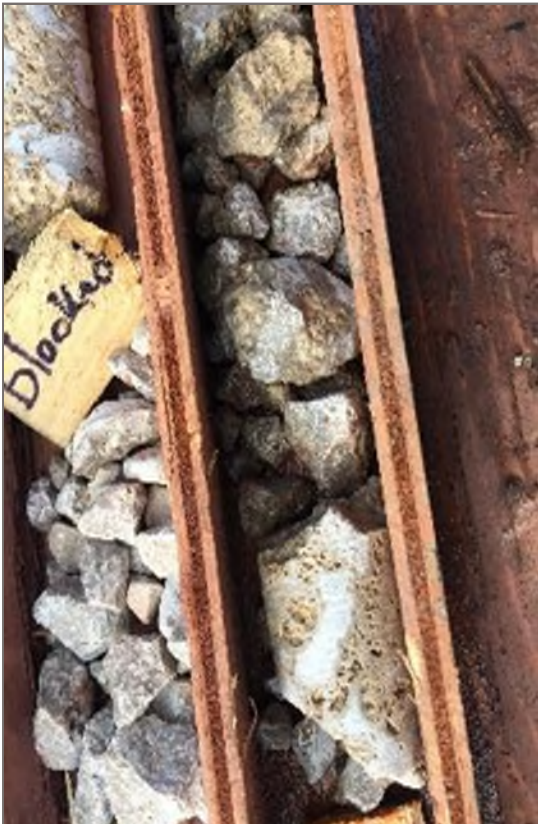
Photo 48: Prospect 86. Recovered drill core from P86-01. Typical weathered, vuggy dolomite encountered in upper 4 to 5 m of all boreholes at Prospect 86. Fine grained calcitic dolomite sands observed in weathered core cavities. Photo taken on July 12, 2017

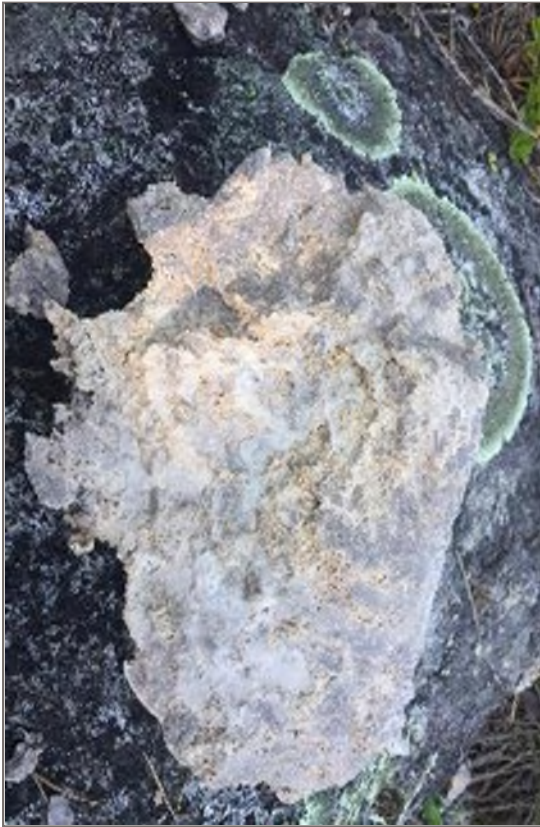
Photo 49: Prospect 86. Calclitic dolomite boulder fractured with rock hammer. Photo taken on July 15, 2017.

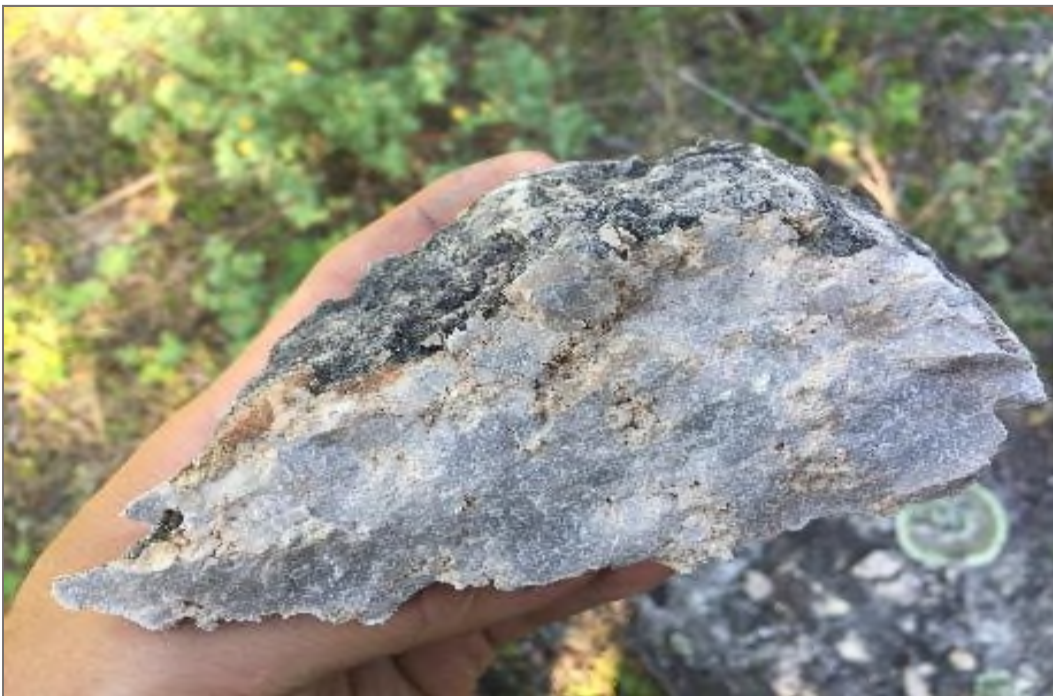
Photo 50: Prospect 86. Close up of calclitic dolomite boulder. Weathered outer surface with lichen growth. Weathered and vuggy material with frequent cavities of weathered sands. Photo taken on July 15, 2017.

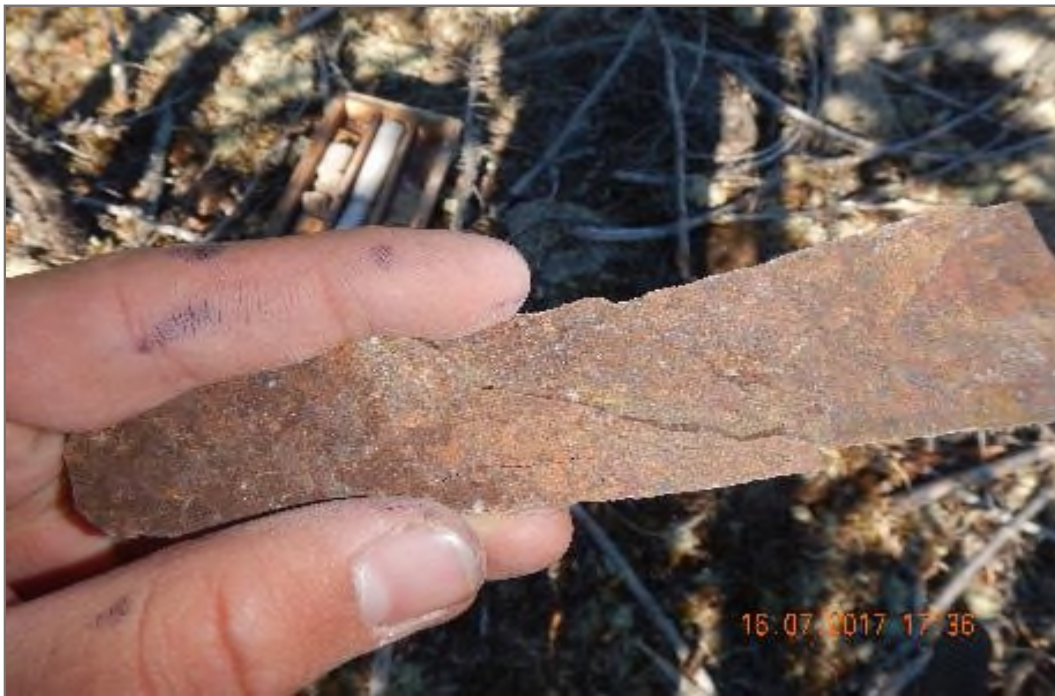
Photo 58: Prospect 105. Iron alteration surface coating typically observed on joints. Photo taken on July 16, 2017.

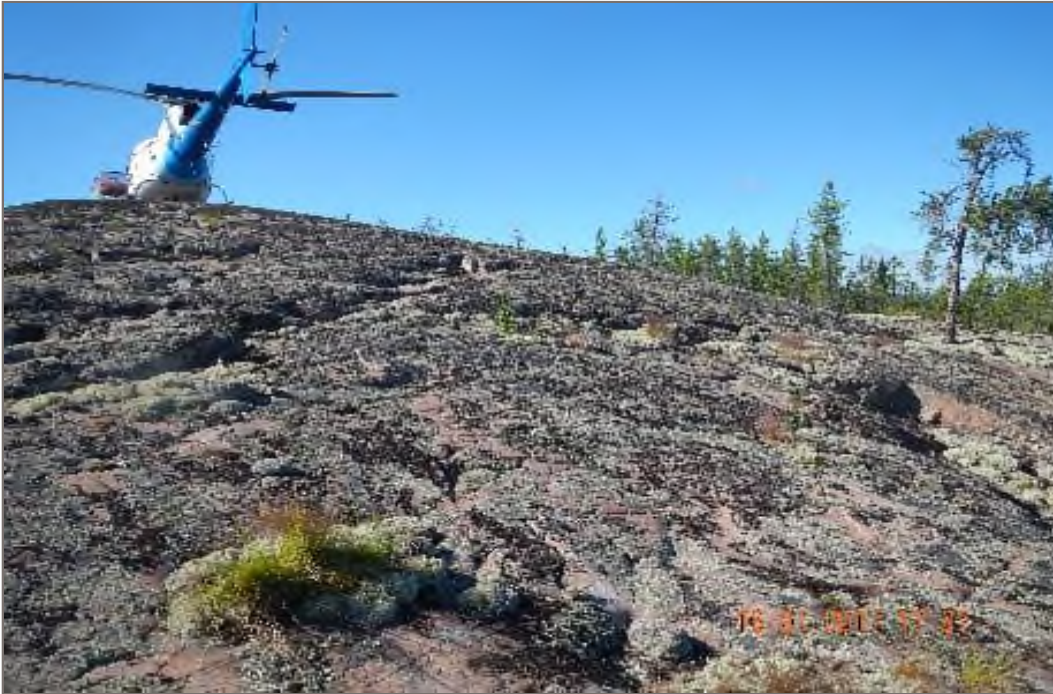
Photo 59: Prospect 105. Bedrock exposure above P105-01.

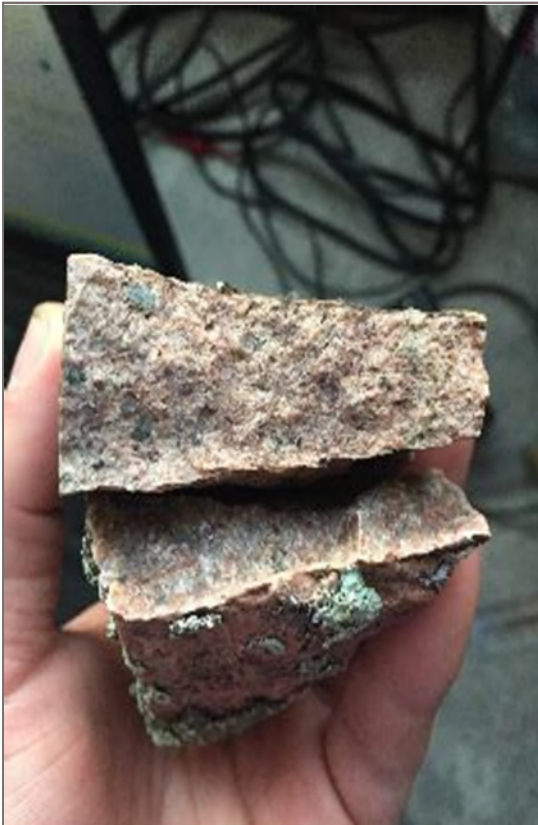
Photo 61: Prospect 105. Fractured boulder from surface of rock outcrop. Photo taken on July 16, 2017

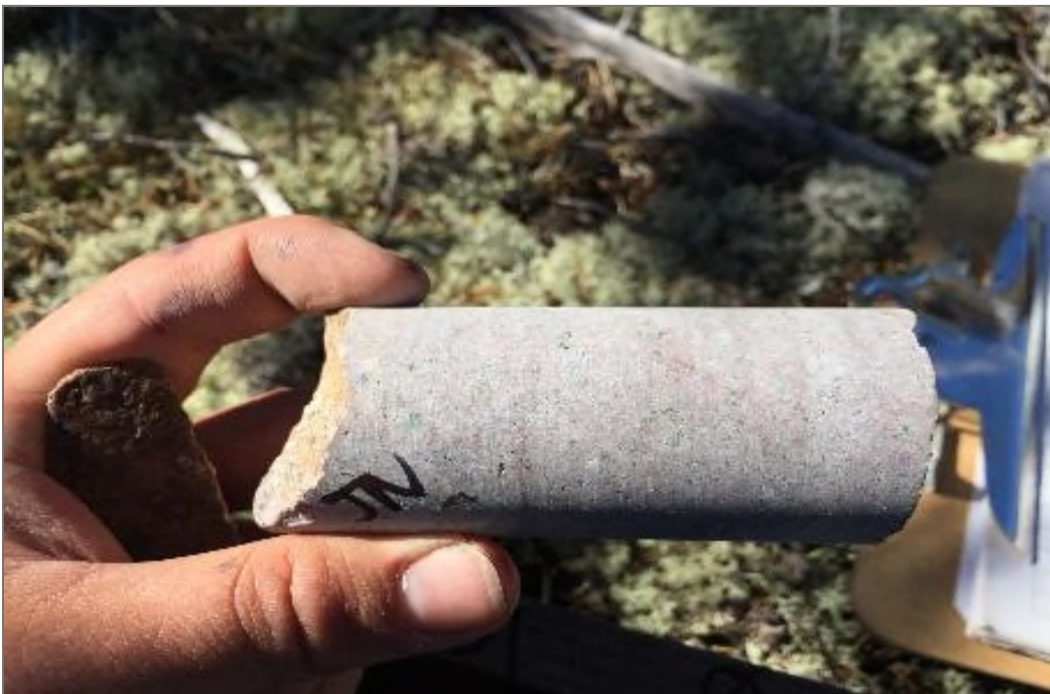
Photo 62: Prospect 105. Typical of recovered granite drill core. Photo taken on July 16, 2017.

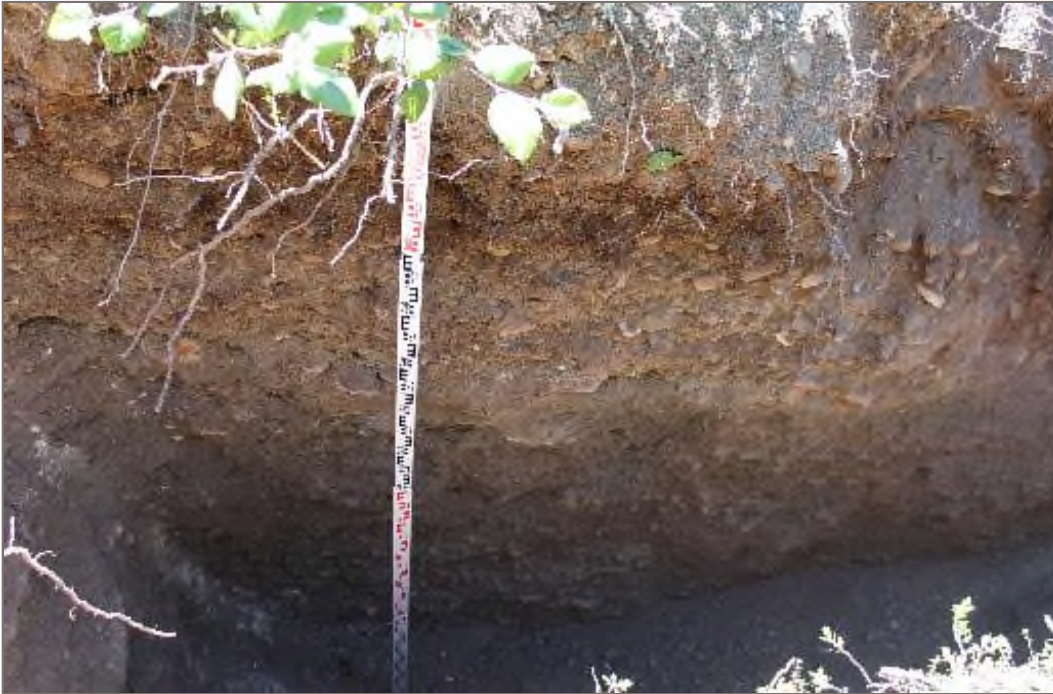
Photo 67: Prospect 116-05. Upper soils were SAND, gravelly and below were SAND and GRAVEL at depth. Permafrost was observed around 1.8 m deep.
Photo taken July 18, 2017

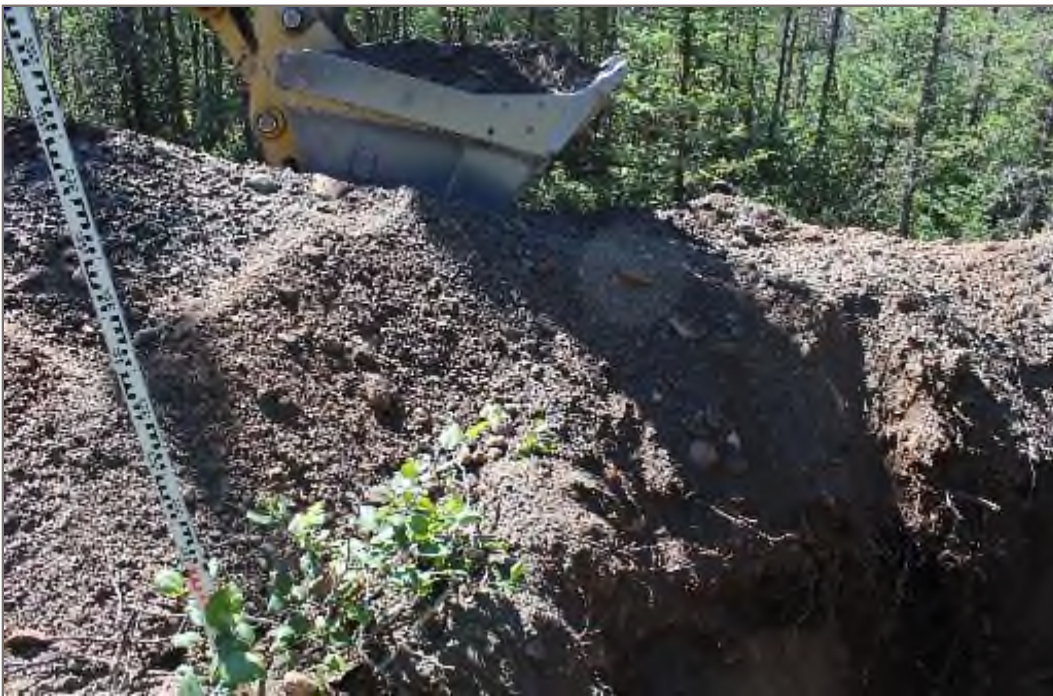
Photo 68: Prospect 116-05. Spoil pile for Testpit 05.
Photo taken July 18, 2017

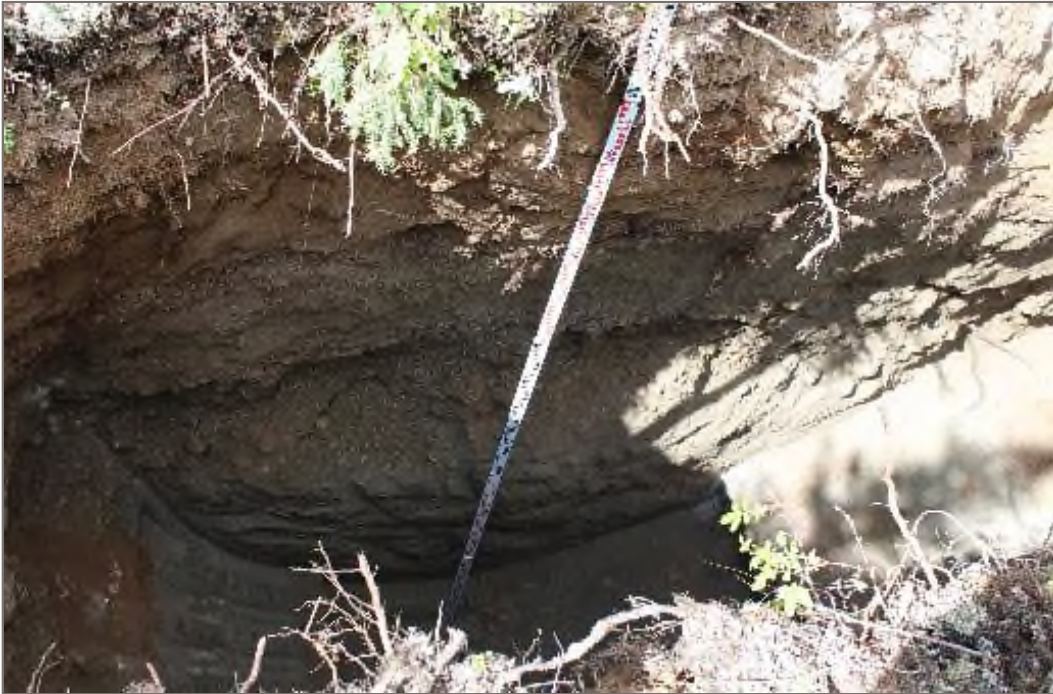
Photo 69: Prospect 116-10. Upper and lower soils were primarily sand. A band of gravel was observed between 1.2 and 2.2 m deep. At 2.2 m, permafrost was observed. Photo taken July 17, 2017

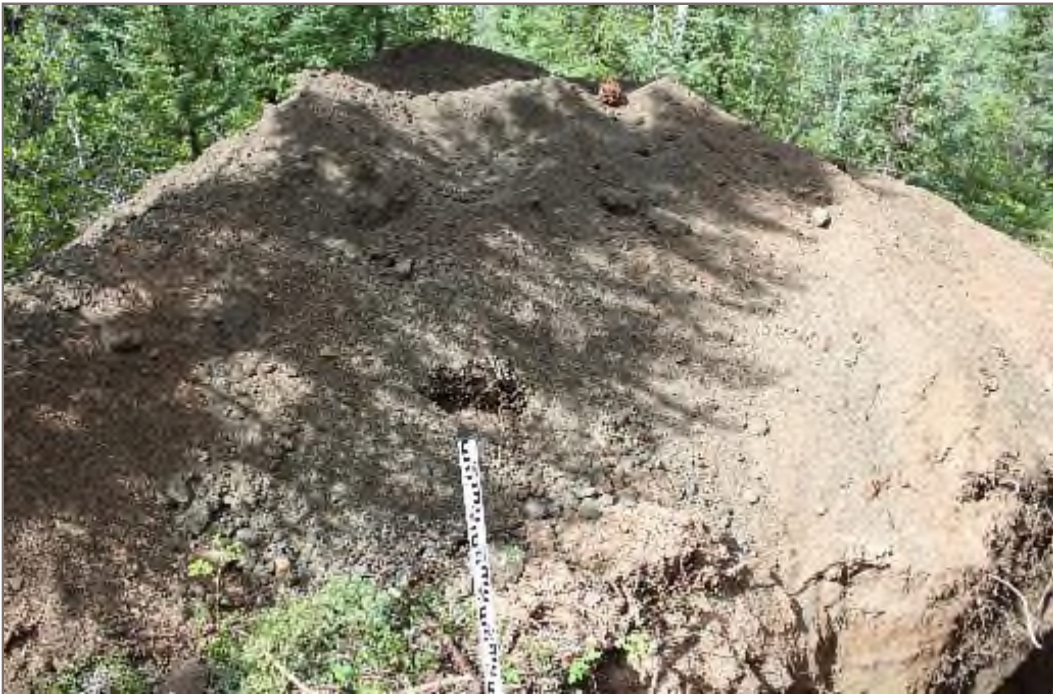
Photo 70: Prospect 116-10. Spoil pile for Testpit 10. Frozen pieces of sand are visible. Photo taken July 17, 2017

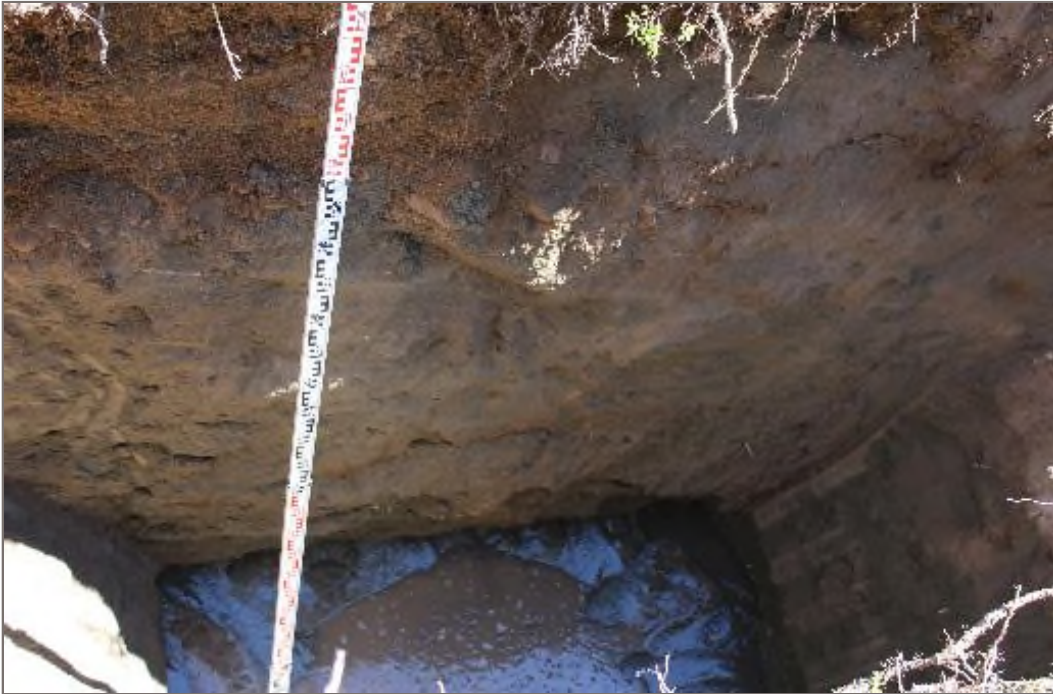
Photo 71: Prospect 116-19. The soil was largely SAND with trace so some gravel noted near the surface. Water seepage observed below a band of permafrost soils at 3.3 m and standing water at 3.6 m upon testpit completion.
Photo taken July 18, 2017

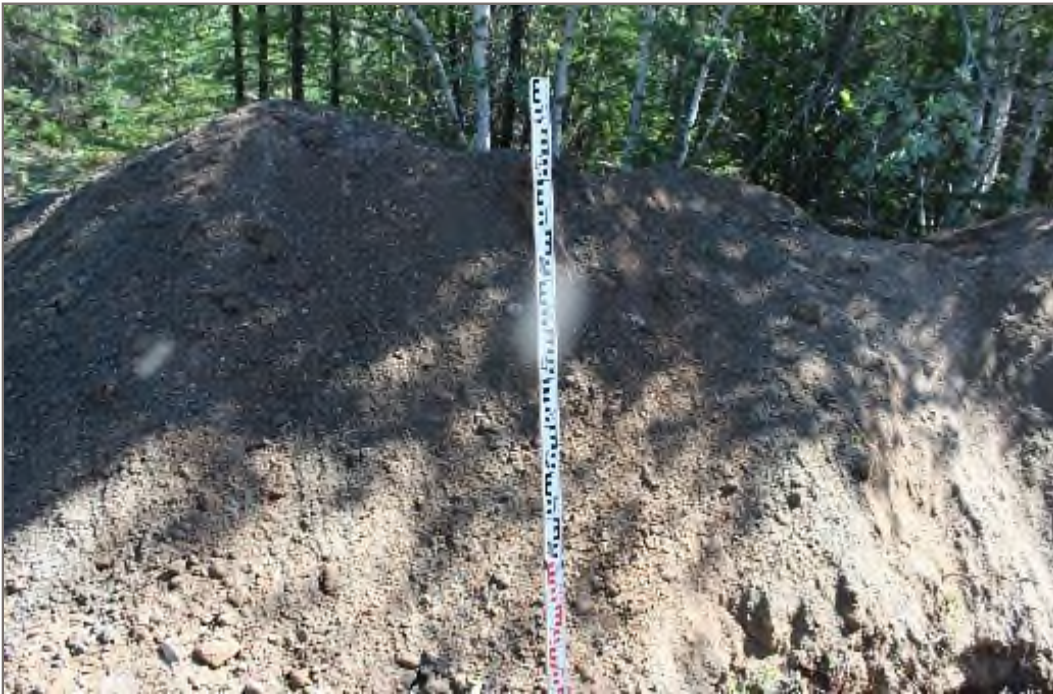
Photo 72: Prospect 116-19. Spoil pile for Testpit 19.
Photo taken July 18, 2017
