March 19, 2024

Patricia Coyne

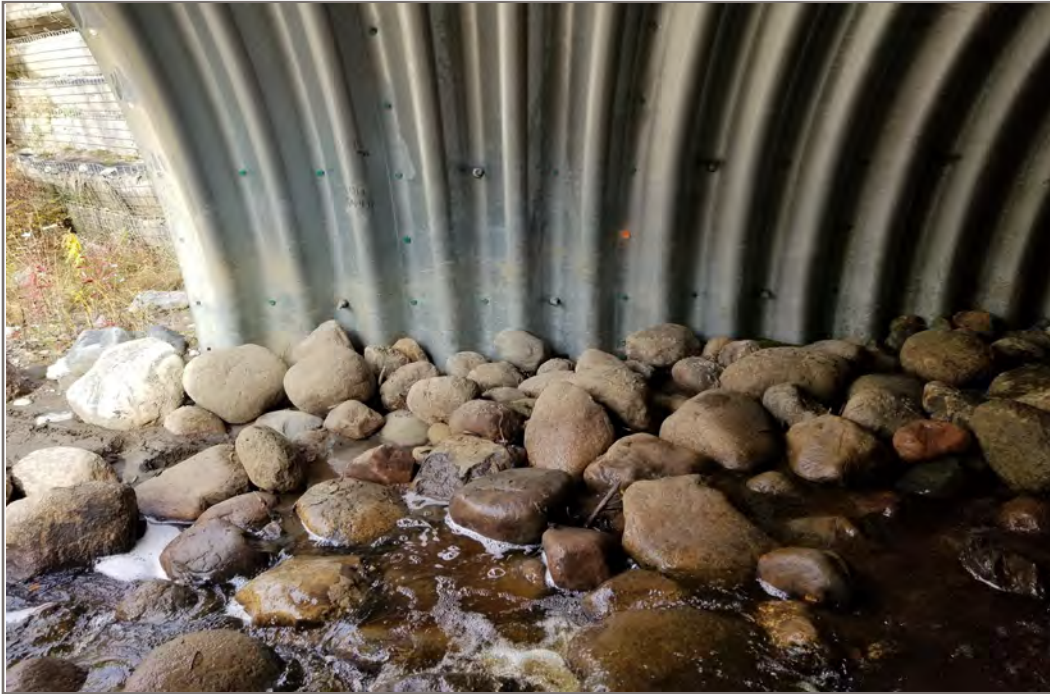
Photo 25: km 752.61 (4 of 7) – Looking at north wall at culvert outlet. Culvert in good condition. Mud lines indicate water has reached 0.65m outlet depth.

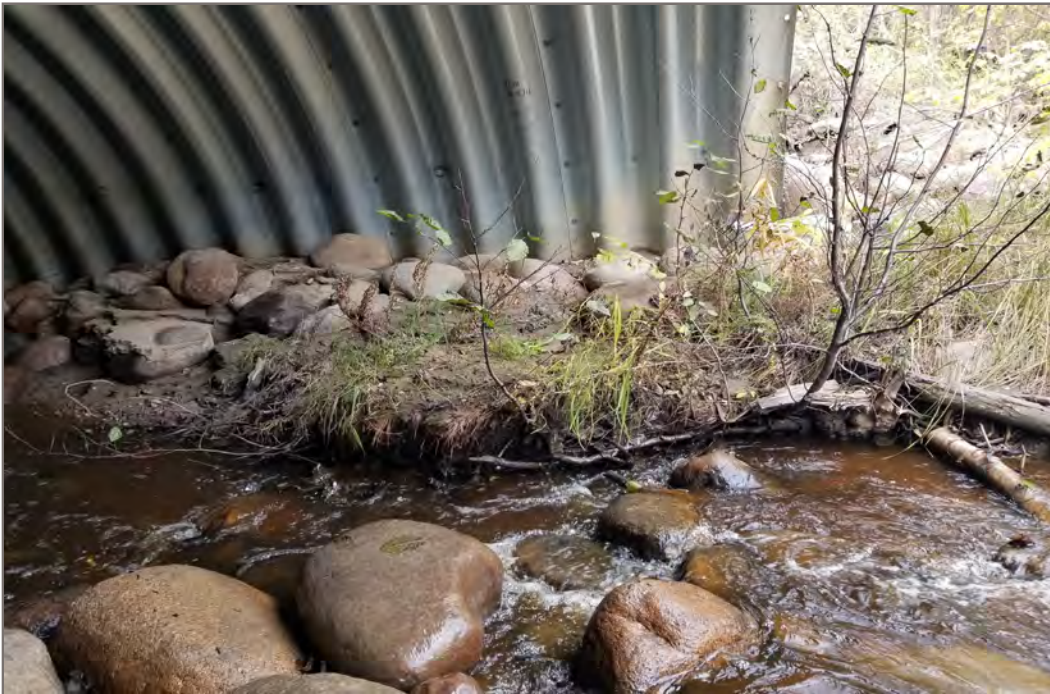
Photo 26: km 752.61 (5 of 7) – Looking at north wall at culvert inlet. Mud lines indicate water has reached 1.0m inlet depth.

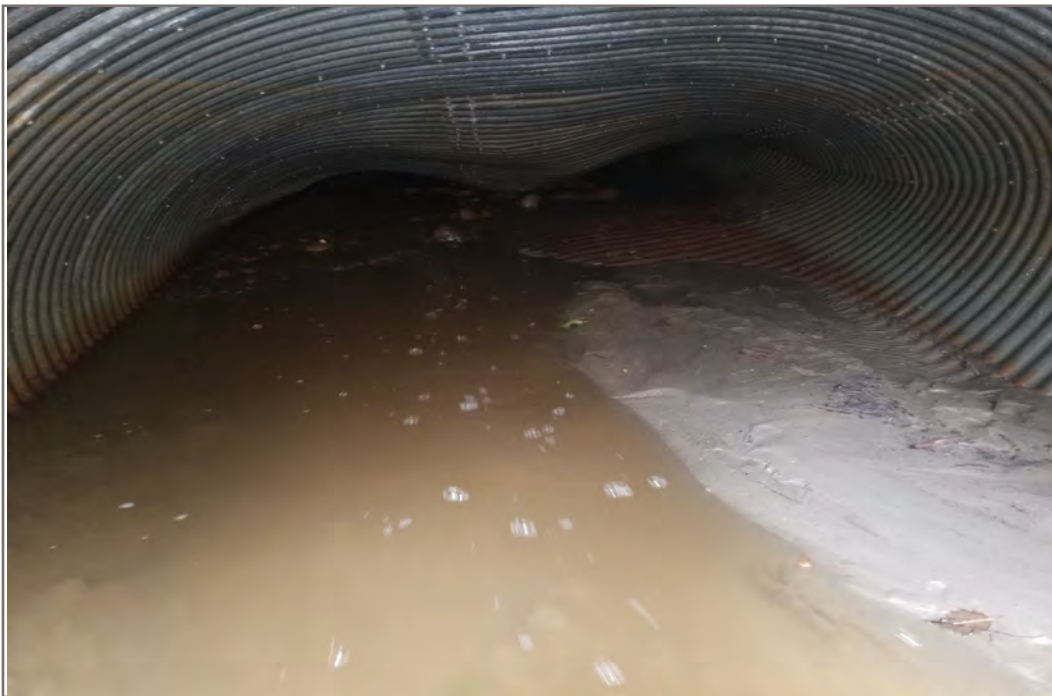
Photo 30: km 748.02 (2 of 7) – Looking east within the culvert outlet. Culvert severely crushed, but all flow at the time of the field visit seemingly still conveyed through damaged pipe.

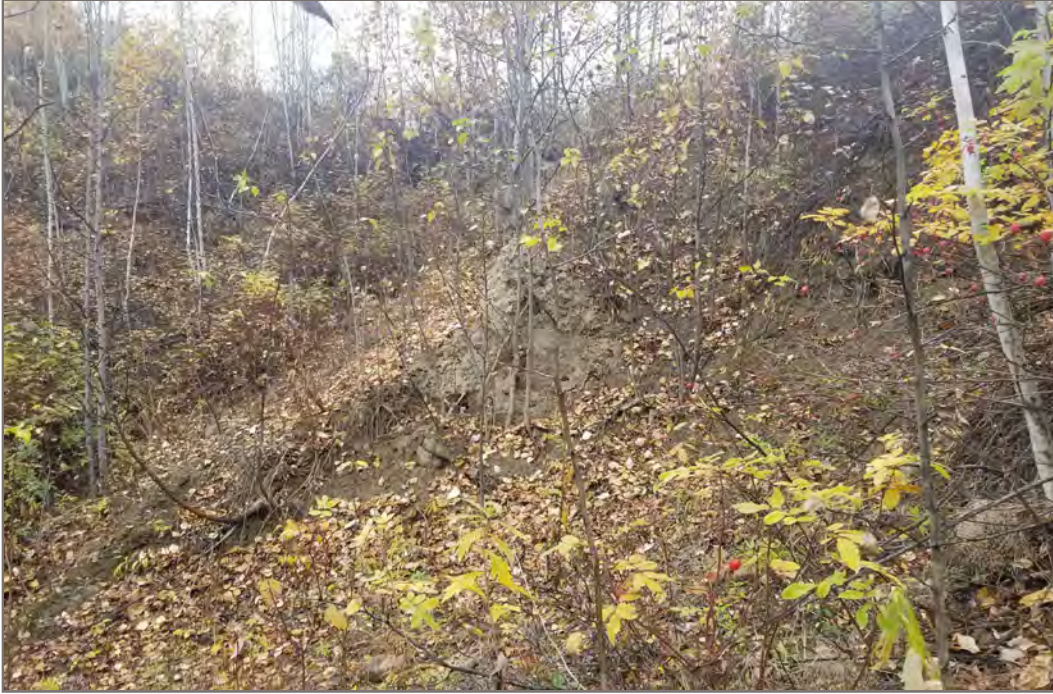
Photo 31: km 748.02 (3 of 7) – Looking north along embankment at embankment loss on downstream end of existing watercourse crossing.

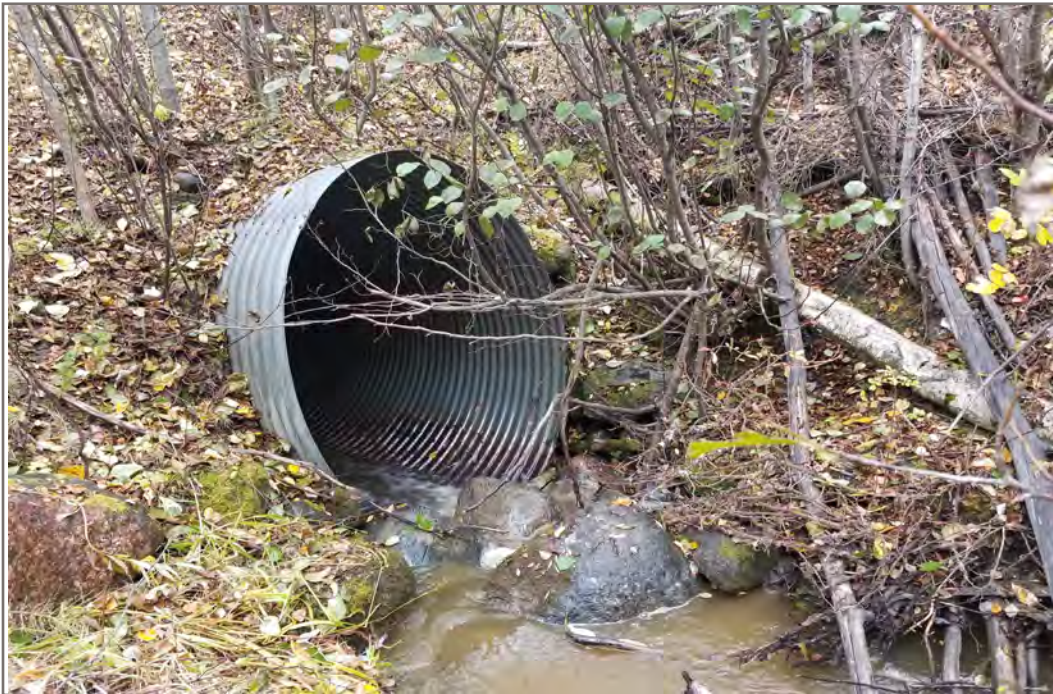
Photo 32: km 748.02 (4 of 7) – Looking at culvert inlet. Inlet has become angled due to internal damage to remainder of culvert within embankment.

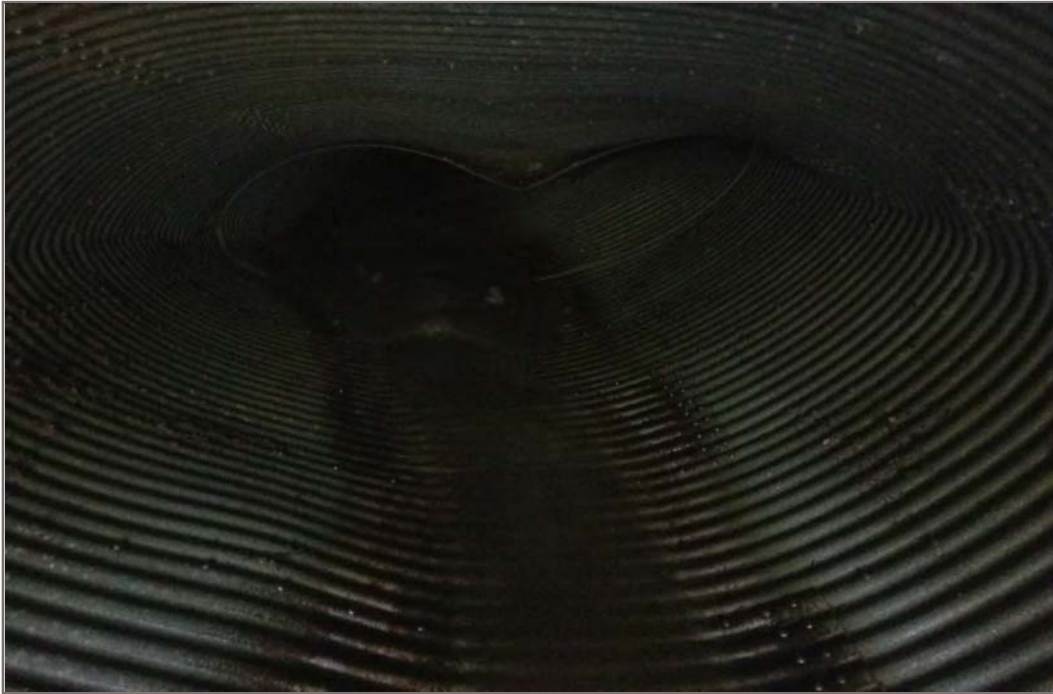
Photo 33: km 748.02 (5 of 7) – Looking downstream from inlet of culvert. Culvert severely damaged.

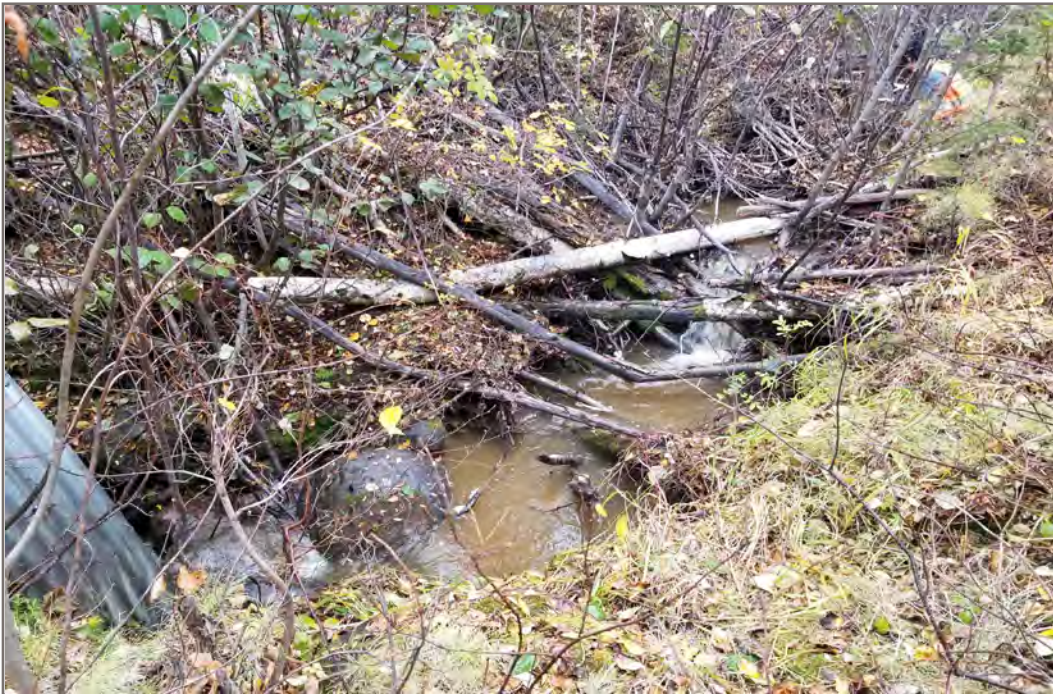
Photo 34: km 748.02 (6 of 7) – Looking upstream (northeast) from culvert inlet. Channel well defined with woody debris present.

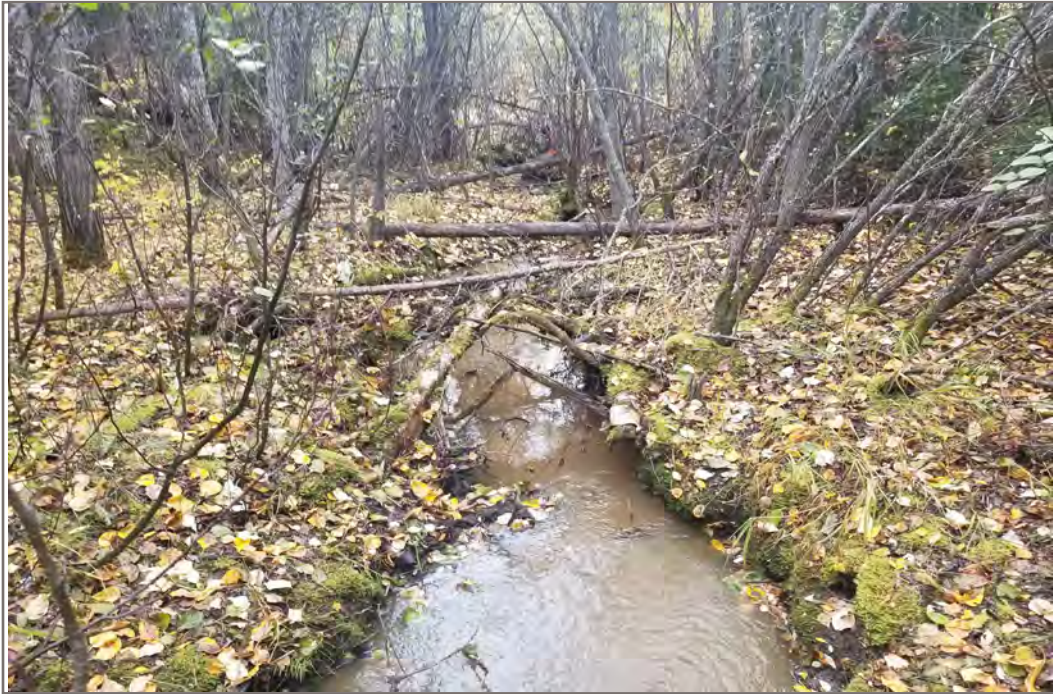
Photo 35: km 748.02 (7 of 7) – Looking downstream approximately 75 metres downstream of existing damaged culvert crossing.

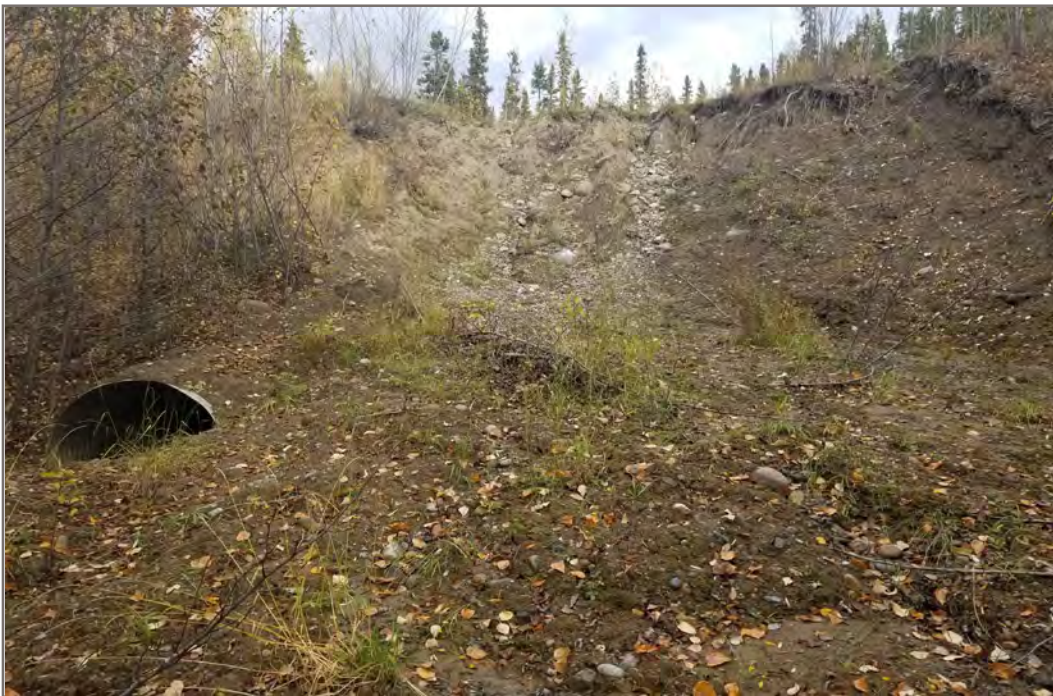
Photo 36: km 747.56 (1 of 7) – Looking east at damage to embankment at outlet end of existing crossing.

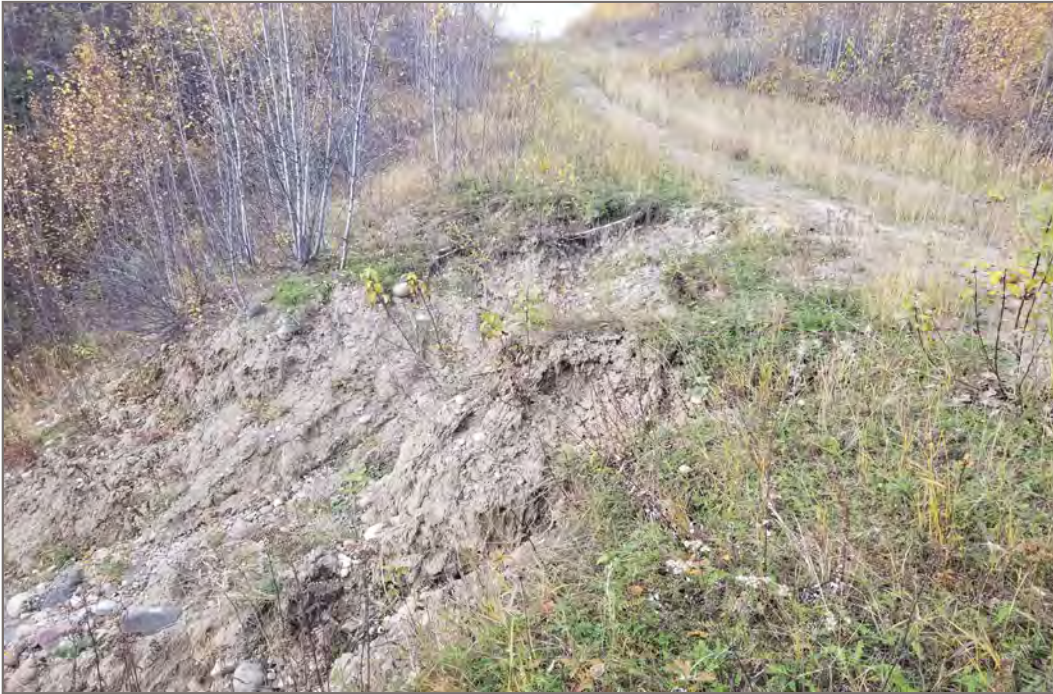
Photo 37: km 747.56 (2 of 7) – Looking north along winter road alignment. Downstream embankment erosion extends to crest and is diminishing available roadway width.

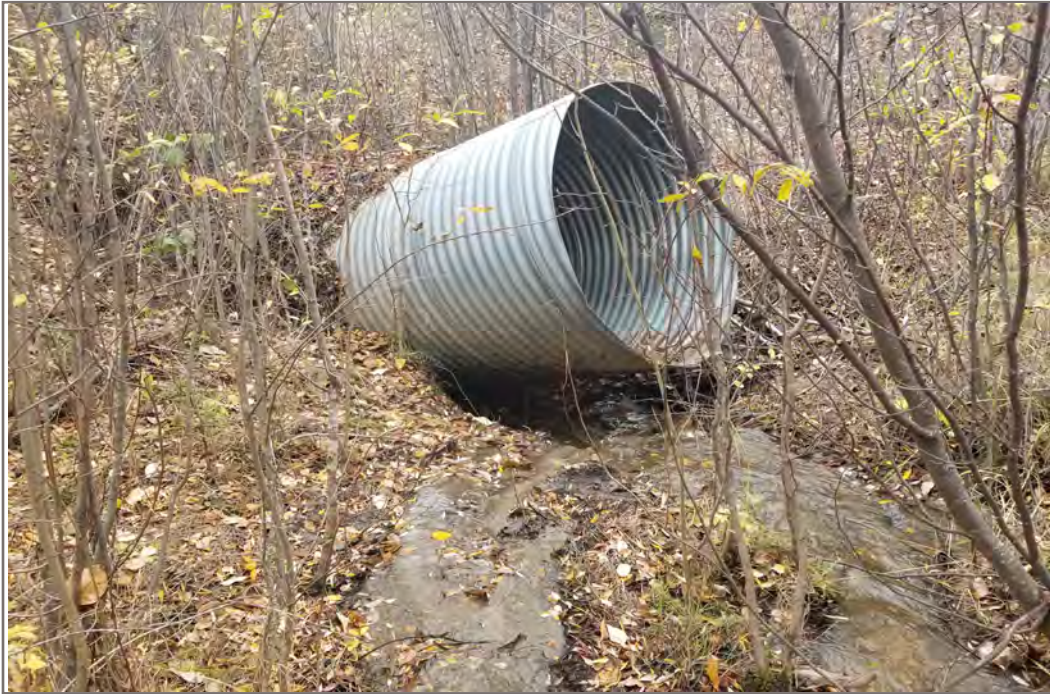
Photo 39: km 747.56 (4 of 7) – Looking north at inlet end of existing culvert. Damage to the culvert within the embankment has forced the inlet to lift. Flow goes underneath inlet, appearing to enter the culvert at the first culvert joint.

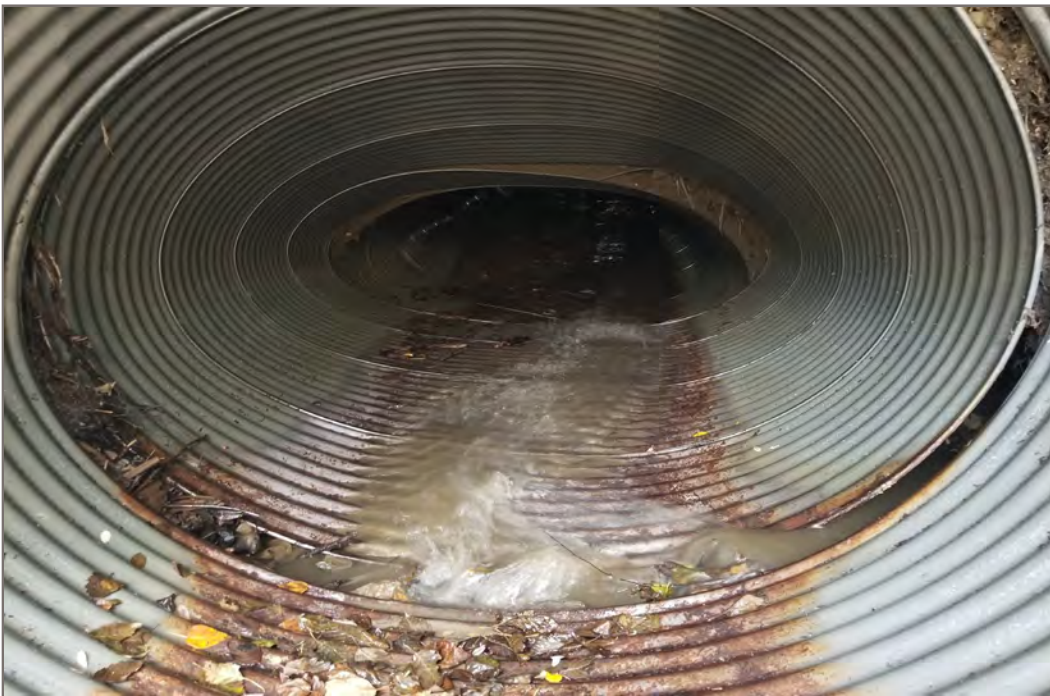
Photo 40: km 747.56 (5 of 7) – Looking west within inlet end of culvert. Culvert is severely deformed, and most joints have been damaged, allowing piping. As the inlet of the culvert is raised above the channel, flow enters the culvert at the first and second joints.

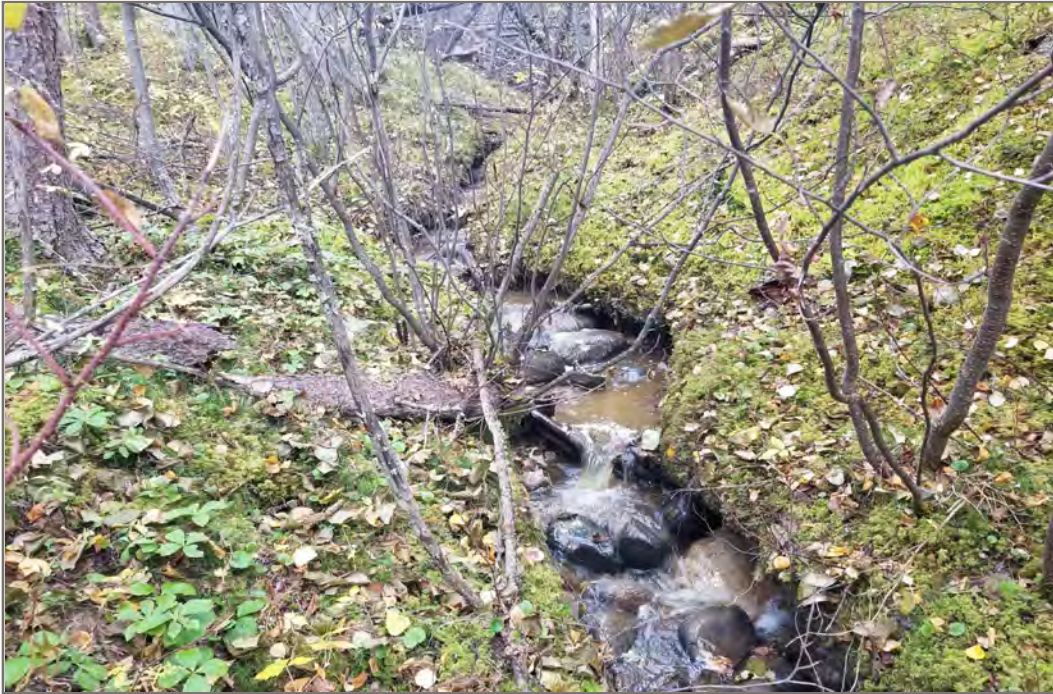
Photo 41: km 747.56 (6 of 7) – Looking upstream (east) approximately 50 m upstream of existing culvert crossing.
