**GEOTECHNICAL/MATERIALS
EVALUATION
PROPOSED DEH CHO BRIDGE
FORT PROVIDENCE, NT**

Project No. 1700063

February, 2004

**EBA ENGINEERING CONSULTANTS LTD.
YELLOWKNIFE, NT**

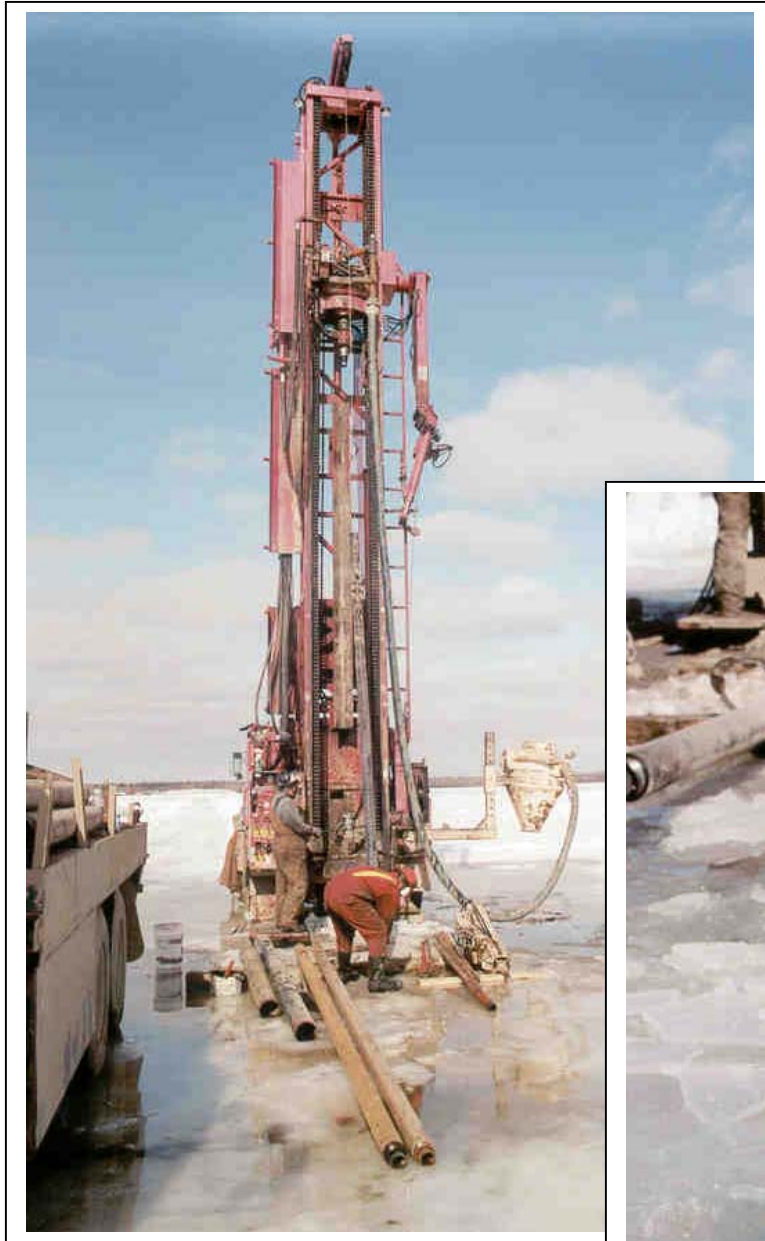
Photo 4: April 17, 2003 – ODEX Drill Bit

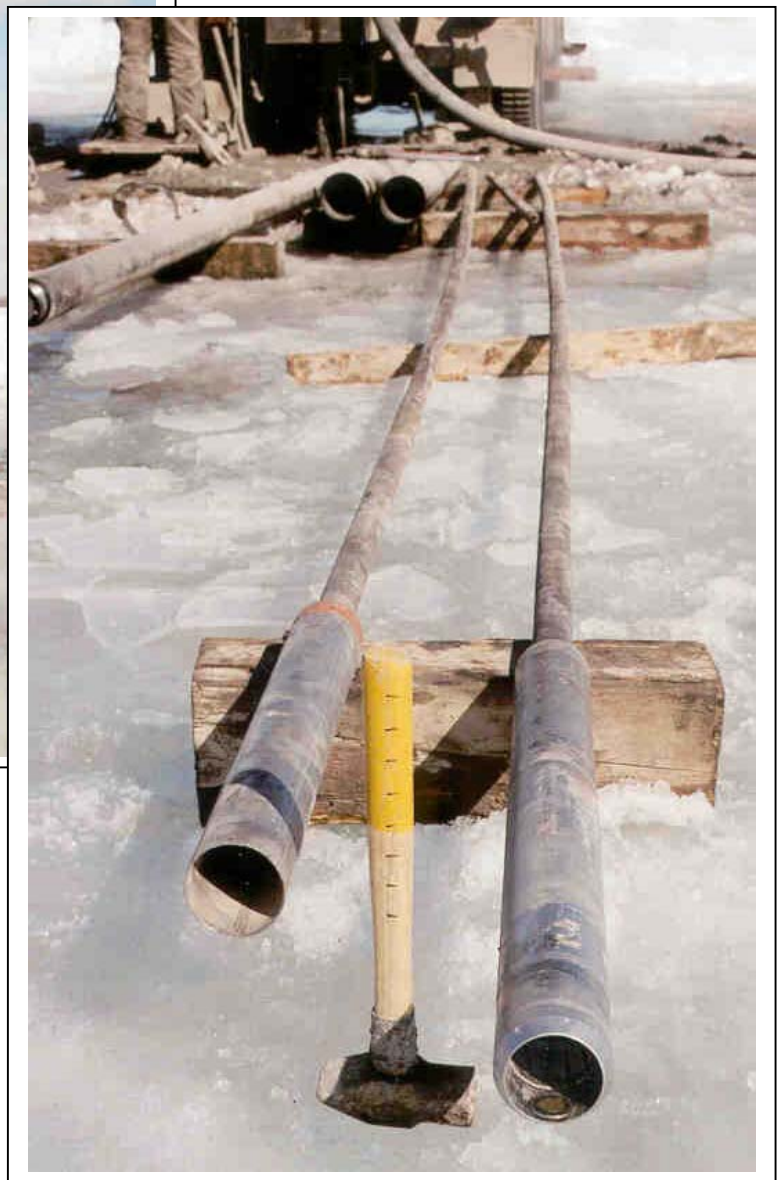
Photo 5: April 8, 2003
- Putting on steel at P-1

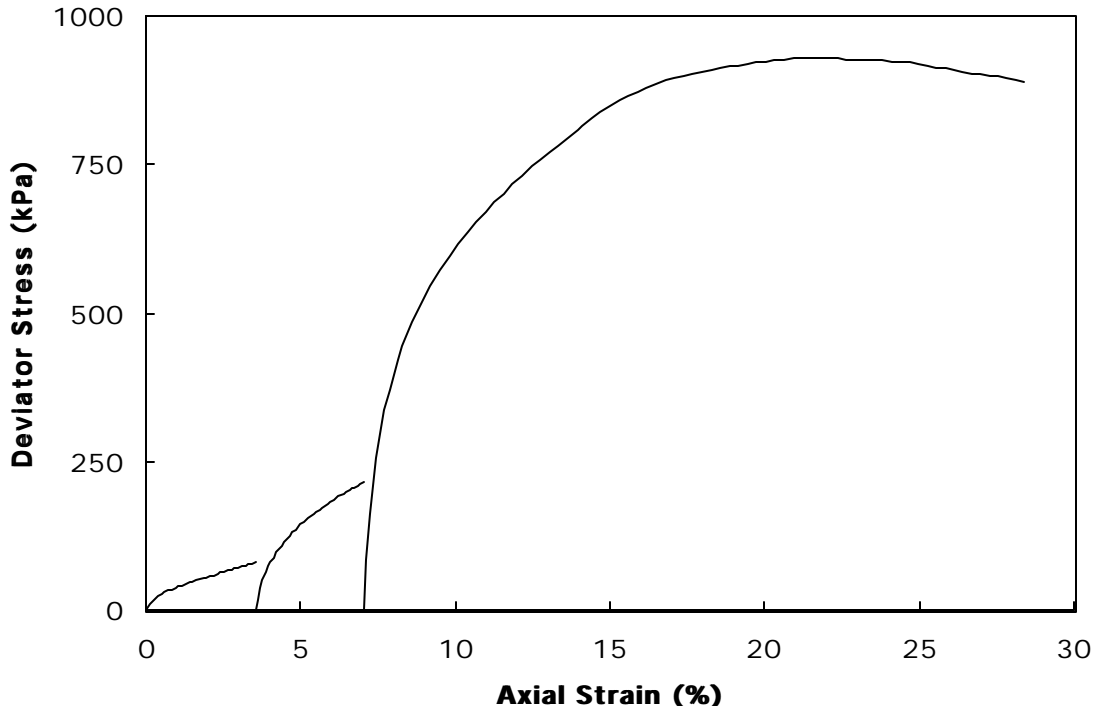
Test Hole: P-7
Effective Stress: 30/120/480 kPa
Strain Rate: 0.015 %/min.
Test No.: CU-2

The appropriate elastic modulus, E , and ν are not generally known for deformations due to consolidation. Considering results from the consolidated undrained triaxial test (CU-2) and assuming plain strain conditions for simplicity, the Poisson's ratios after Stage 1, 2, and 3 of consolidation are 0.48, 0.45 and 0.39 respectively. The decreasing trend in ν indicates increased stiffness with increased effective chamber pressure. These values are in agreement with previous studies, which show decrease in ν when material stiffness increases (e.g. Bowles, 1982). Poisson's ratio calculated from plane strain conditions is twice than that obtained from a triaxial test (e.g. Das, 1997). Estimated values of ν determined from the triaxial test results, range from 0.19 to 0.24 for the hard clay till.

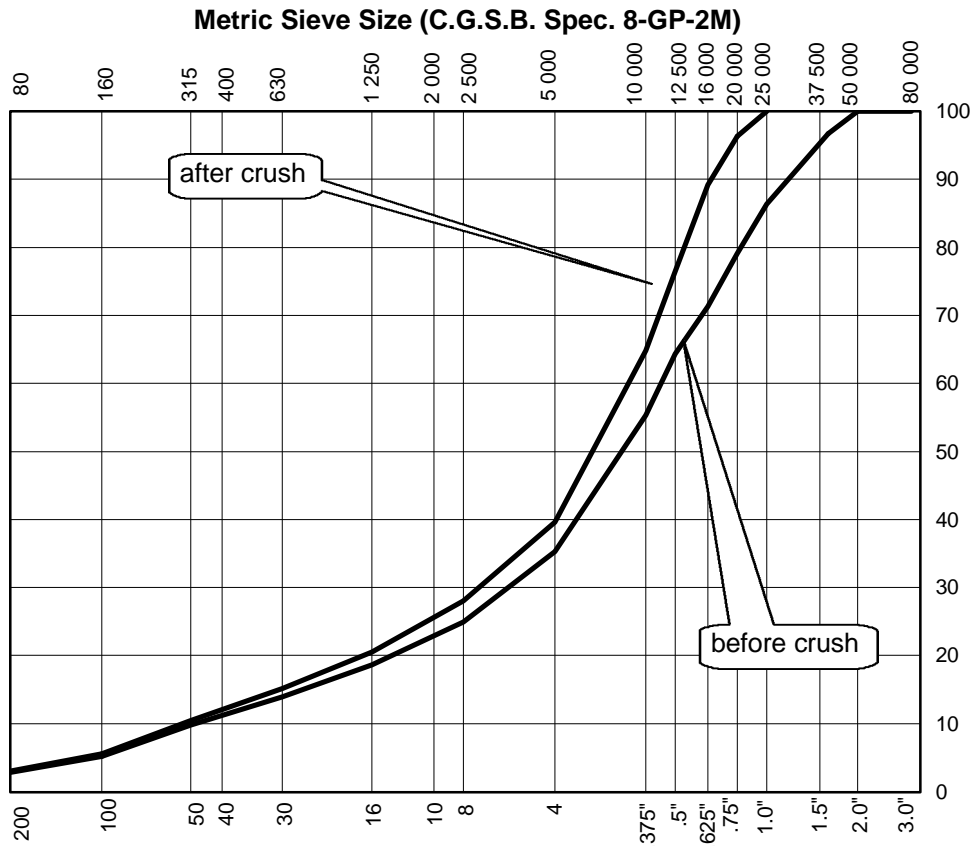
Sieve Sizes		% Passing
U.S.	Metric	
3"	80 000	
2"	50 000	100
1.5"	37 500	97
1"	25 000	86
.75"	20 000	79
.625"	16 000	71
.5"	12 500	64
.375"	10 000	55
No. 4	5 000	35
No. 8	2 500	25
16	1250	19
30	630	14
50	315	10
100	160	5
200	80	2.8

From the sieve results, it can be seen that the fine aggregate fraction (5 mm minus) represents about 35% by mass of the sample as received. This is about the right proportion of sand to gravel for concrete aggregate. It can also be seen that through crushing the sand (5 mm minus) fraction increases to about 40%, which could be somewhat high. Regardless of the aggregate top-size for the mix produced, it is recommended that the aggregate be separated on a 5 mm screen to allow control of the coarse and fine fractions in the mix.

The fines content (percent passing a 0.08 mm sieve) of the sample received was determined to be 2.8 percent. Assuming a theoretical split of the material on a 5 mm screen, the fines content of the fine fraction would be 8 percent. This significantly exceeds the specified maximum of 3 percent (5 percent in the case of manufactured fines; CSA A23.1-00). Therefore, EBA would normally recommend that the fine aggregate be washed. Washing concrete aggregates has not become standard practice in the Northwest Territories. Local experience suggests that it should also be possible to address this deviation from CSA specifications in the mix design and through the use of appropriate admixtures. A trial batch was recommended to verify this.
